Historic Preservation Plan
and Guidelines for

Sands North Townhouses

Historic District

Scottsdale, Arizona

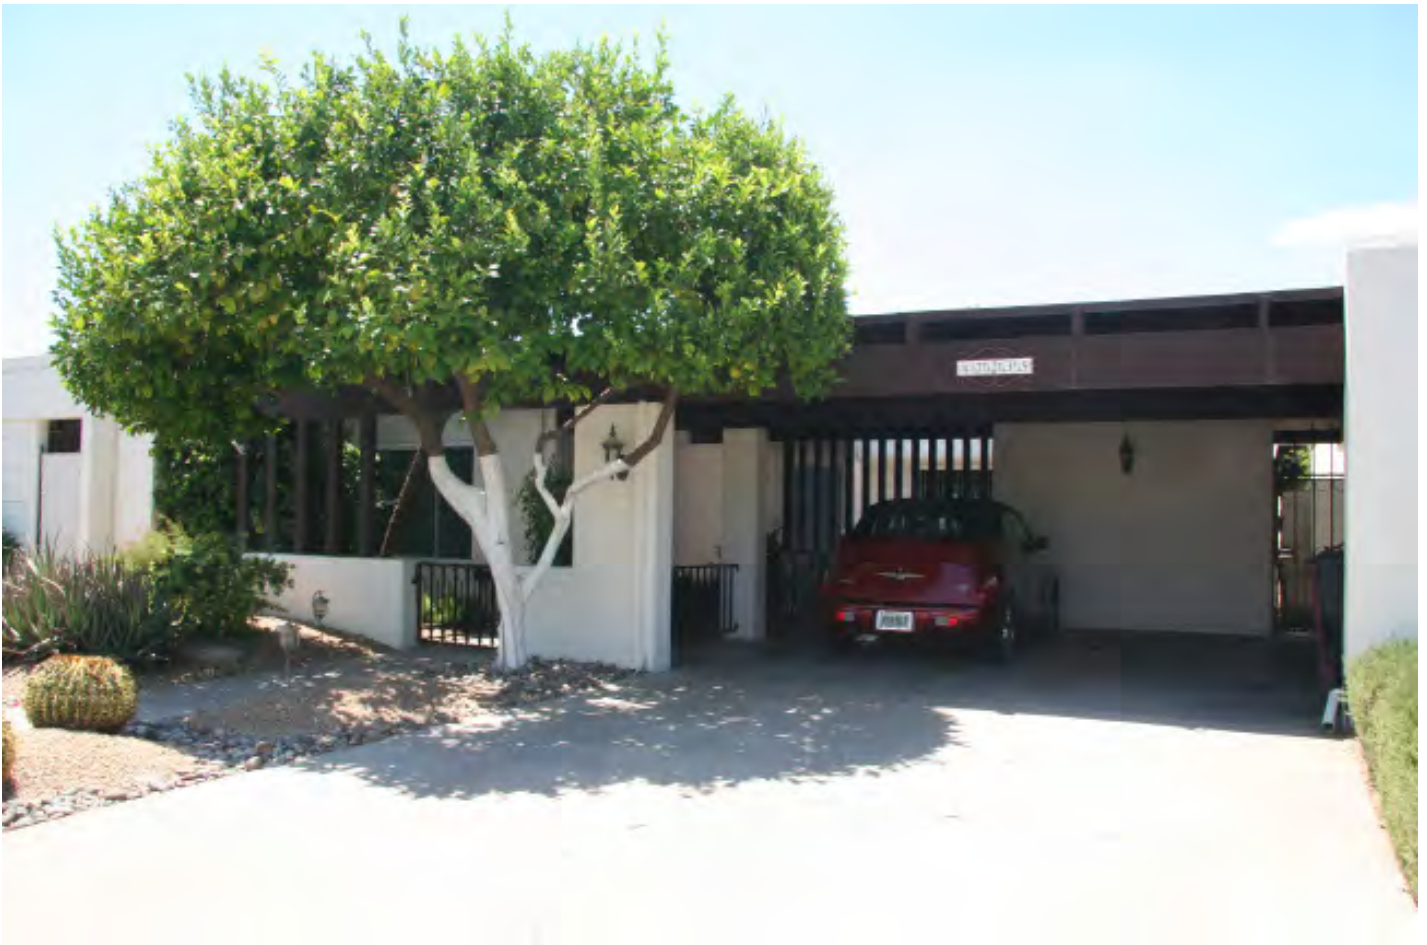
Lot 23, Type A1 - Wood post screen on stucco wall and wrought iron gate

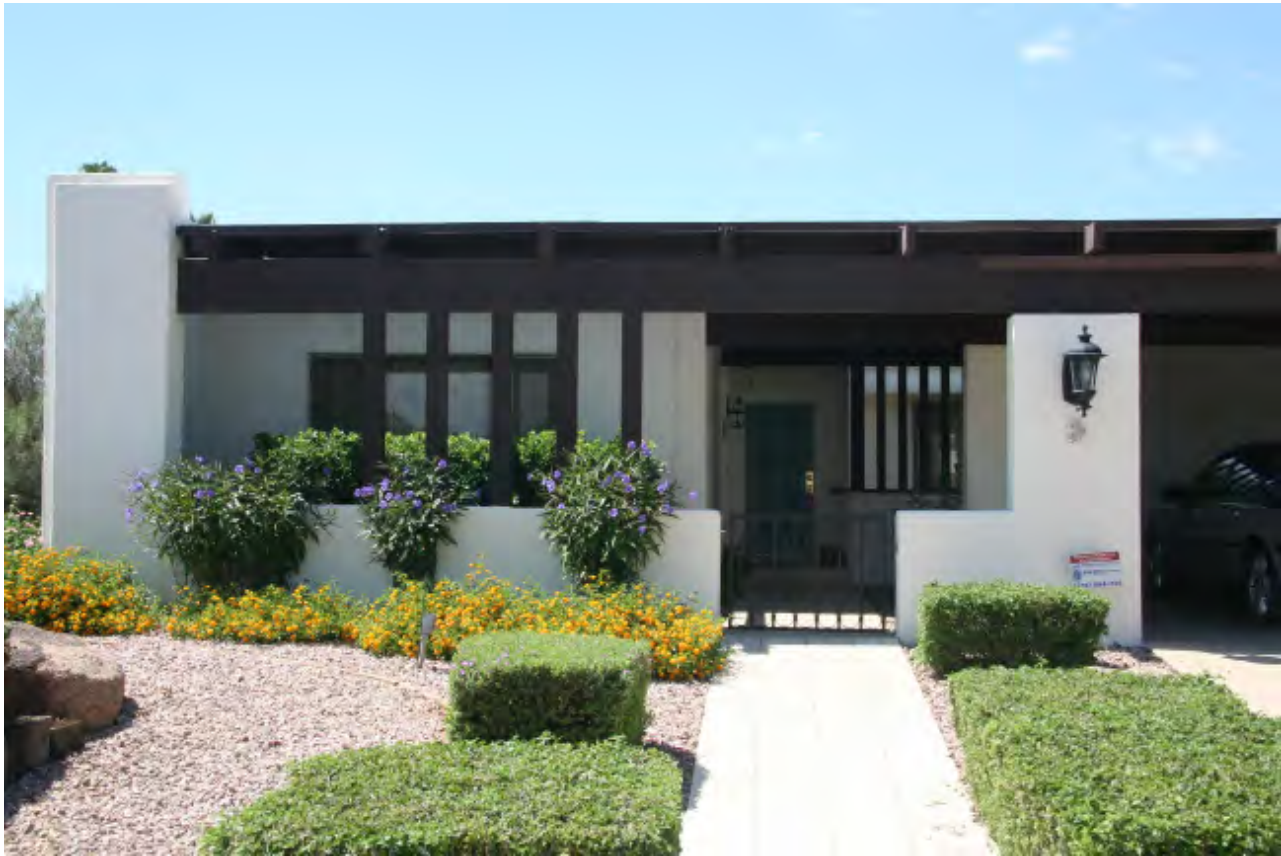
Lot 30, Type A - Low wall with wood post screening and wrought iron gate

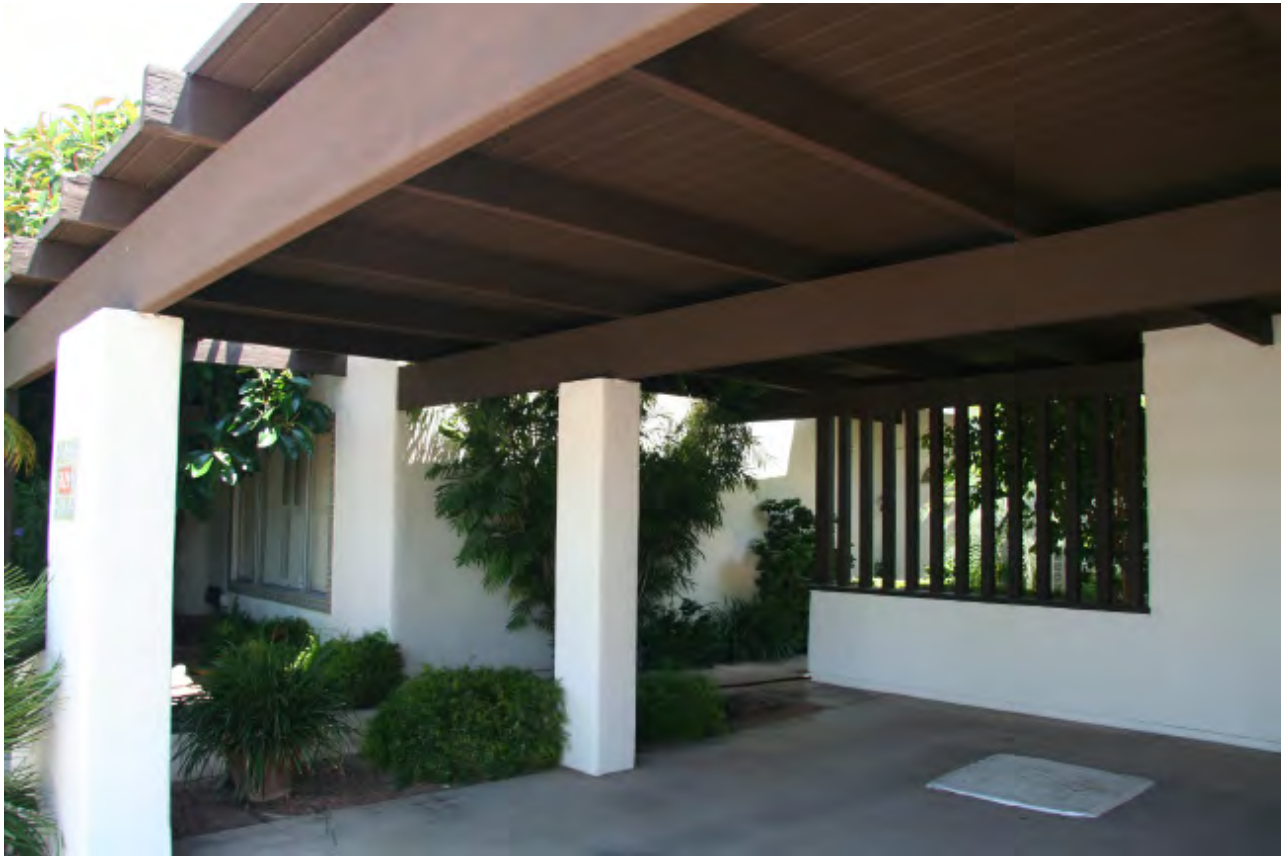
Lot 51, Type A1 - Wood beams and exposed rafters

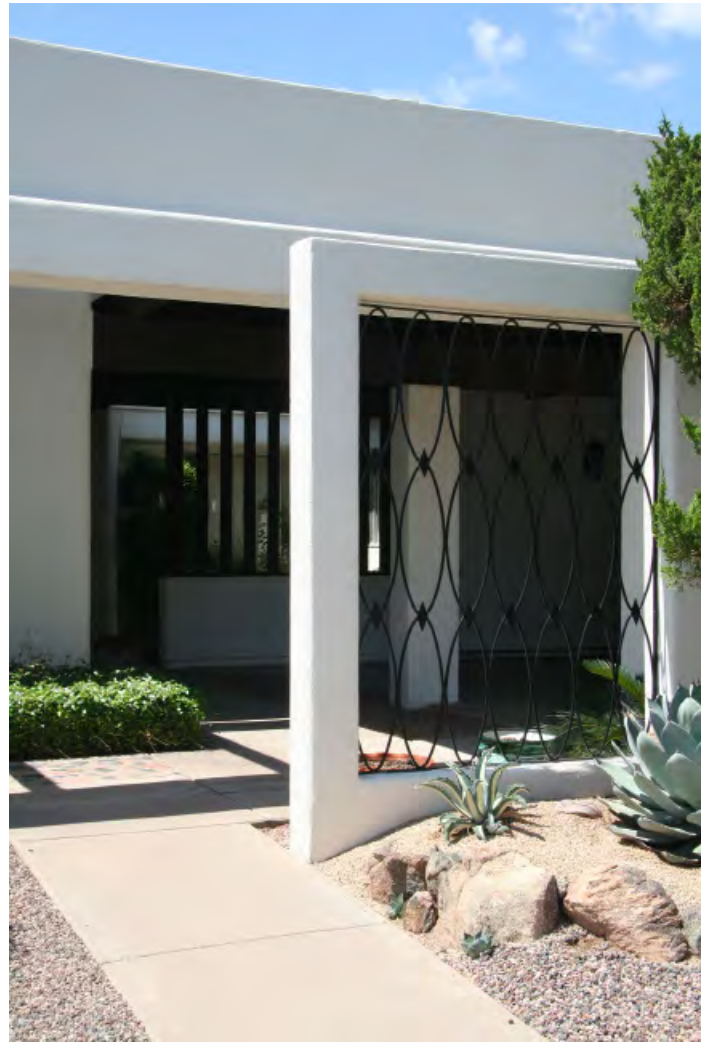
Lot 28, Type A3 - Screens at entry

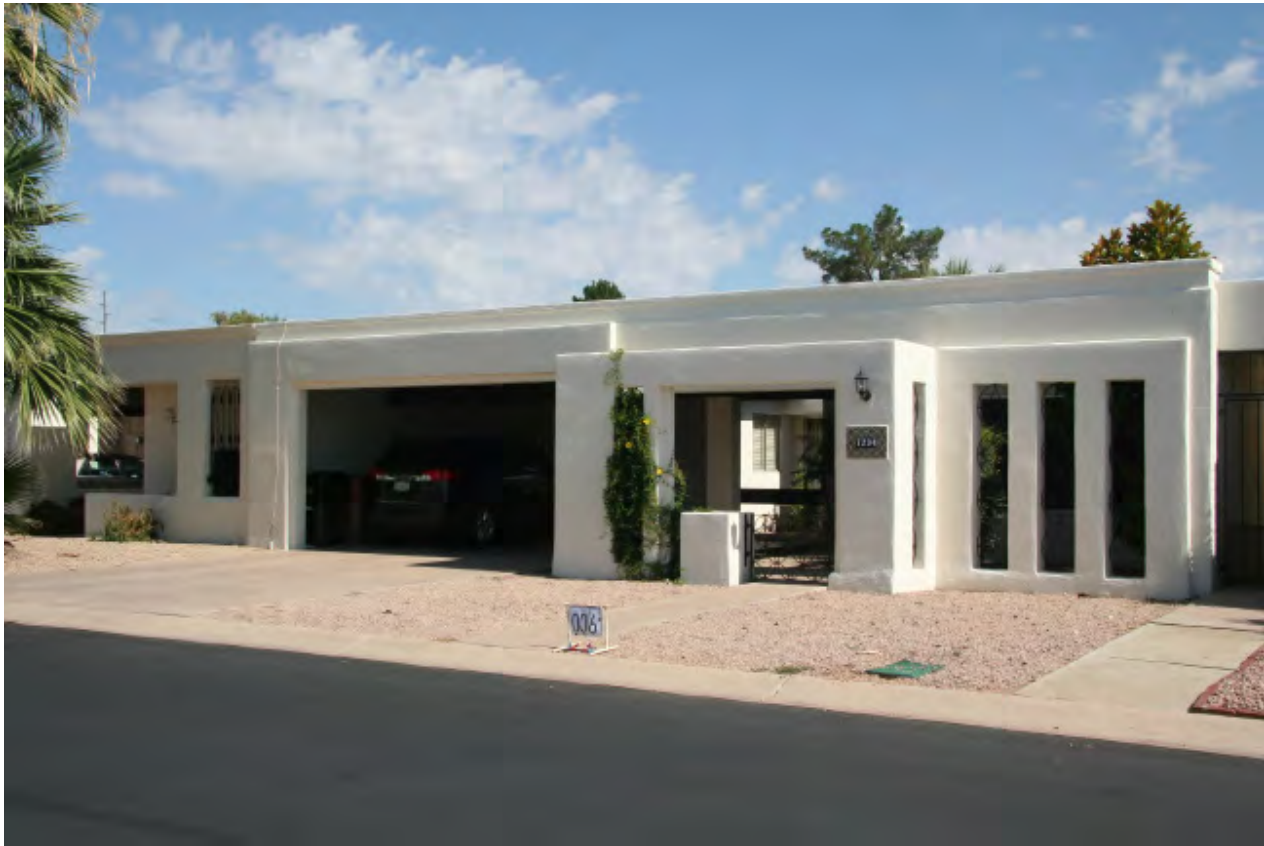
Lot 8, Type A2

- Exposed wood beam interior of carport
- Stucco columns between carport and walkway
- Screen between carport/ inner courtyard – stucco/ wood
- Side alley access with metal gate located beyond carport; metal gate in most cases mimics front metal ornamentation

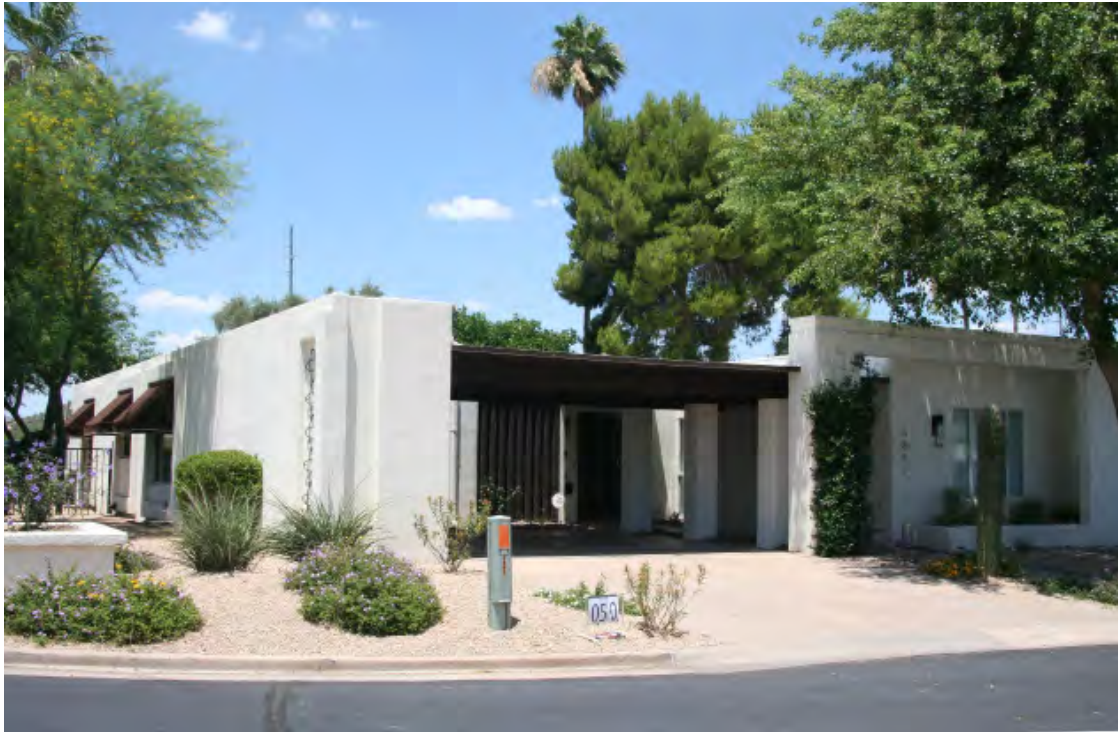
Lot 12, Type C1

- Front wall has an integrated partial-height planter and large rectangular opening at entry walkway; the house wall is setback the depth of the planter
- Additional opening in the front wall was originally infilled with decorative metal
- Partial-height stucco wall between carport and entry walkway
- None show any screen at rear of carport

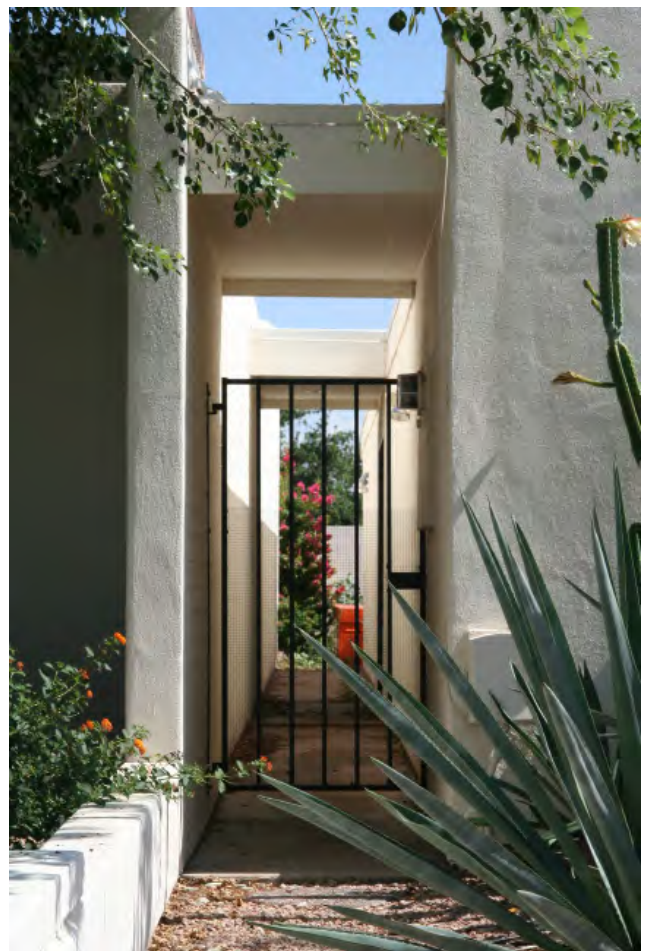
Lot 1, Type D1

- Front wall is solid and decorated with grid block, centered and recessed on wall
- Low-wall planter at front

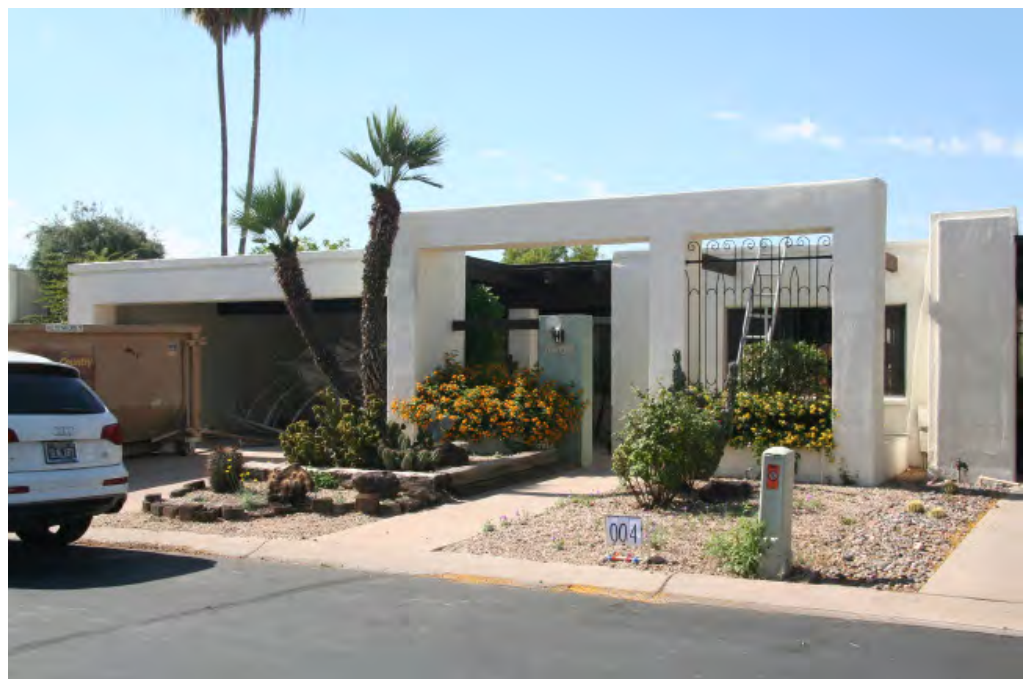
Lot 39

This is a one-story, L-shaped home with an open carport. A semi-engaged wall on the façade has a large square arch for an entry walkway and a smaller opening infilled with decorative metal. The main opening/entry has a freestanding partial wall covered with original aqua tile. Exposed rafters meet this front element. Exposed rafter tails occur at the side elevation as well. The rear section of the townhouse has clerestory windows; a narrow rectangular front patio lies beyond. A concrete column divides the carport from the entry. Exposed beams/rafters occur at the entry. Exposed beams also are found on the interior of the carport, with also has a stucco wall with a wide opening. The entry is a double wood door. Roof apertures occur above the entry walkway and front courtyard.

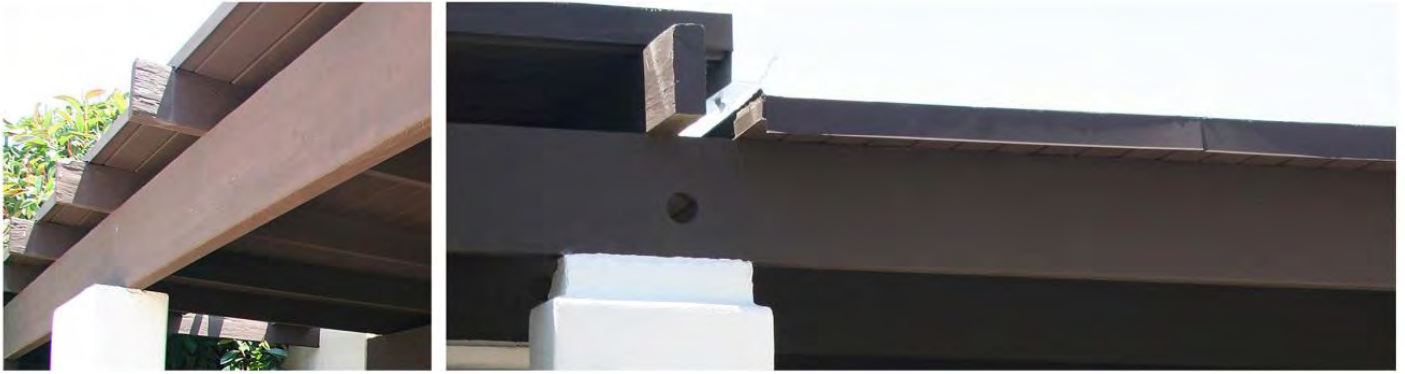
Roof extension and flashing modifications to protect exposed wood members

Guideline 4.2.a: Repairs or replacement of visible roofing should duplicate the original material and appearance. However, protecting exposed carport beams may necessitate the extension of the roof line forward. This alteration of the roof is permitted. See additional discussion of flashing and water protection in Architectural Exterior Features-Wood Elements, below.

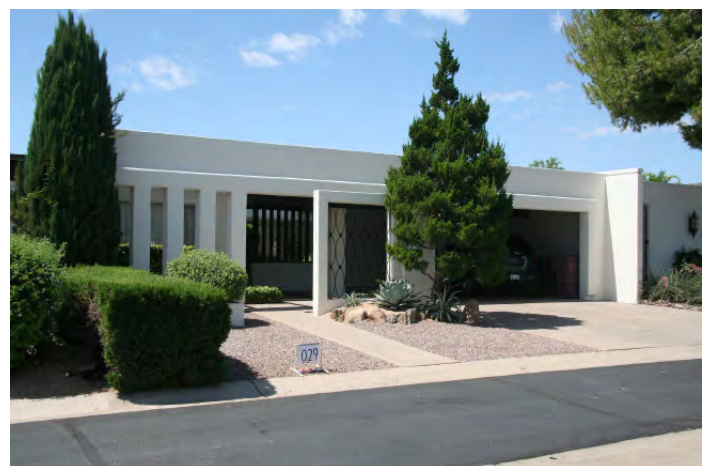
Due to the original roof eave designs, some beam or joist ends have been exposed to the elements and may deteriorate. It is acceptable to add weather protection to these elements in the form of painted metal flashing over the tops of the beams. Such an addition is permitted provided the flashing has a simple profile and that it is painted to match the

beam color. Replacement of wooden beams with metal beams or wrapping of wood beams with metal sheeting is not appropriate. See additional discussion of flashing and water protection in the Roof section above.

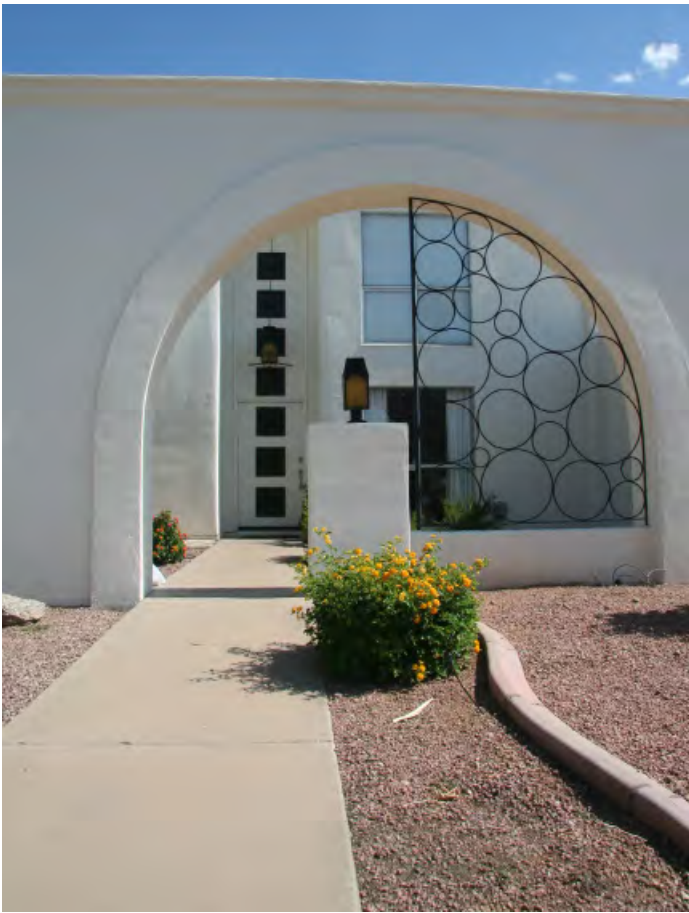
Guideline 4.7.a: preserve inset metal work details occurring on corner units. Decorative metal insets at the corner units are unique to these units and

are designed to appear as one continuous pattern. Replacement or repair of the door is permitted as long as it replicates the original and matches the panel above the door. The decorative raised elements on the doors and panels above door should not be removed.

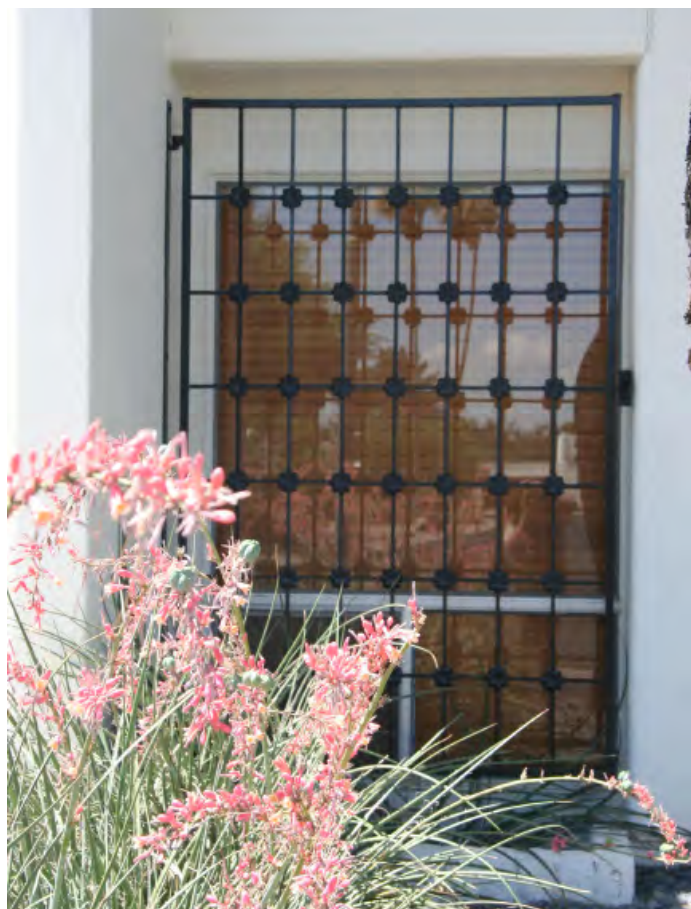
Guideline 4.9.a: Original windows should be preserved and maintained; where they must be replaced due to damage, deterioration, or the need for energy efficiency improvements, new windows should be of the same material, pattern, and finish and glazed with glass with a clear and colorless appearance. The windows used in the development of Sands North were consistent throughout the community. A variety of types and

proportions were used, always rectangular, combining fixed lights with sliding vent panels. All appear to have been mill finish or clear anodized aluminum with single glazing. This was typical for builder construction in the 1960s and 1970s. About 15% of the units have had the windows replaced as of 2015. In most cases they have followed the original patterns or styles but in different finishes, such as white paint or dark/black anodizing; the replacements are a noticeable departure from original appearance, particularly the darker frames.

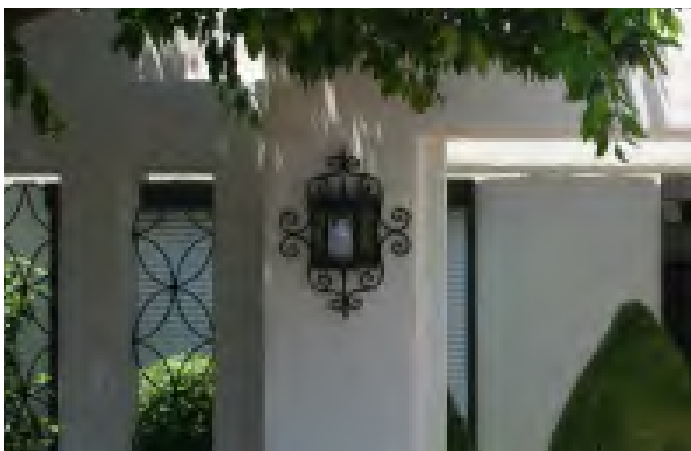
Guideline 4.13.a: House numbers should not be replaced unless they have been damaged or if in the future the numbering is changed; and if replaced, should reflect the type and style of the originals. Like the exterior lighting fixtures, by design there are a variety of house number styles present. These range from ceramic tile house

number plaques to metal letters of different styles and sizes. Typically, the style of the house numbers and the lighting fixtures is consistent within a single townhouse. The range of colors for the metal numbers is limited to brushed steel/aluminum, black or dark bronze. The ceramic tile house numbers – present in 25% of homes in 2015 – are plaques varying in detail, but often consistent with other tile detailing on the townhouse. The majority of the house number/number plaques are located on one side of the entry walkway on an available wall. Some townhouses have numbers/plaques above the carport opening. If numbers must be replaced, the new numbers should be consistent with the finish and style of other features on the townhouse such as the light fixtures.
