Reata Wash Flood Control Improvement Study

Contract No. 2014-168-COS

Design Concept Report Volume I - Report November 2, 2016

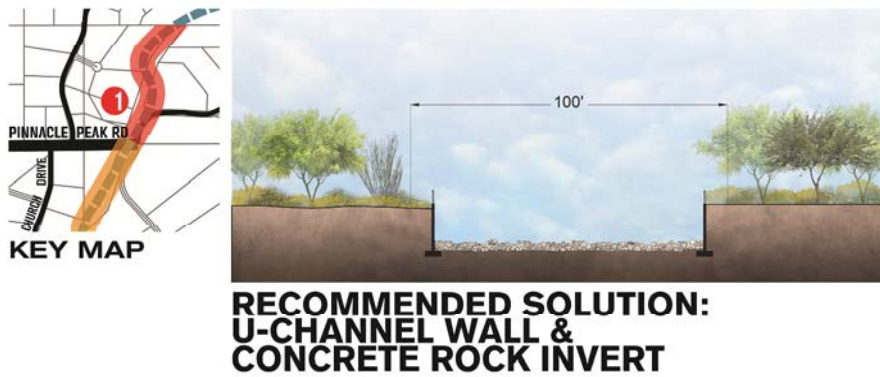
Figure 8.1 Reach 1 Landscape

The typical context sensitive native plant vegetation proposed for each reach for the three alternative solutions identified in this study (the Recommended Solution, Alternative B and Alternative C) are represented as shown in Figures 8.1 through 8.7.

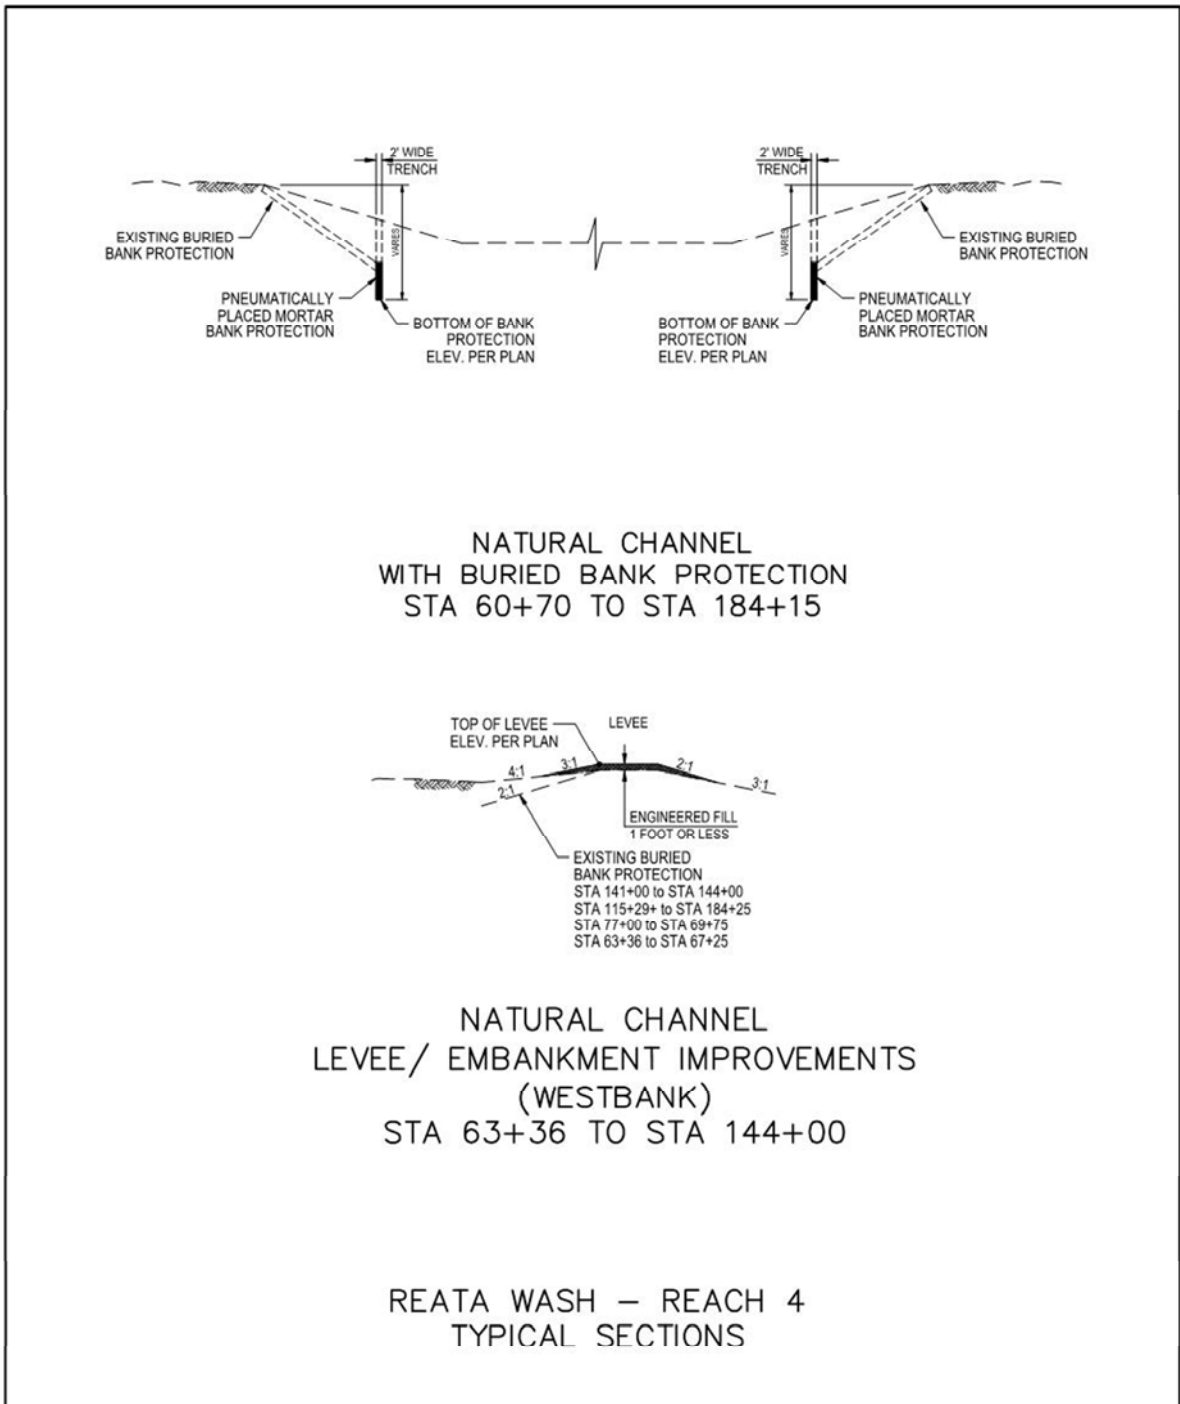
Figure 16.5 Reach 4 Typical Sections

It was determined that there are three locations where levees or levee like embankment structures occur. These areas are located along the west bank area of Reach 4, More investigation is required for these areas. The Bell Road levee may be FEMA complaint with more earth fill to address a freeboard deficient. Increased bank heights and localized channel grading are recommended improvements at the other locations to meet potential levee or embankment requirements. The cross sections for the recommended buried bank protection and levee/embankment improvements are as shown on Figure 16.5 (Reach 4 Typical Sections).

There are three locations within this reach where existing culverts convey low flows from Reata Wash to the southwest; however, no reduction in peak discharges have been applied to the Reata Wash study corridor downstream of these culverts. The 100-year peak discharge is contained within City land rights along this entire reach. The benefits of the recommended solution for this reach are that it can be constructed within the limits where the City has land rights, it is considered context sensitive, favorable to wildlife and has a reasonable maintenance cost.
